## **Example Building Condition Survey Report**

**Address  
Address  
Address  
London**

## **Example Report London**

Client: Mrs E Xample  
Site address: London  
Date of survey: 11<sup>th</sup> October 2016  
Surveyors: Ronnie Campbell BSc MRICS  
Weather: Dry and Mild

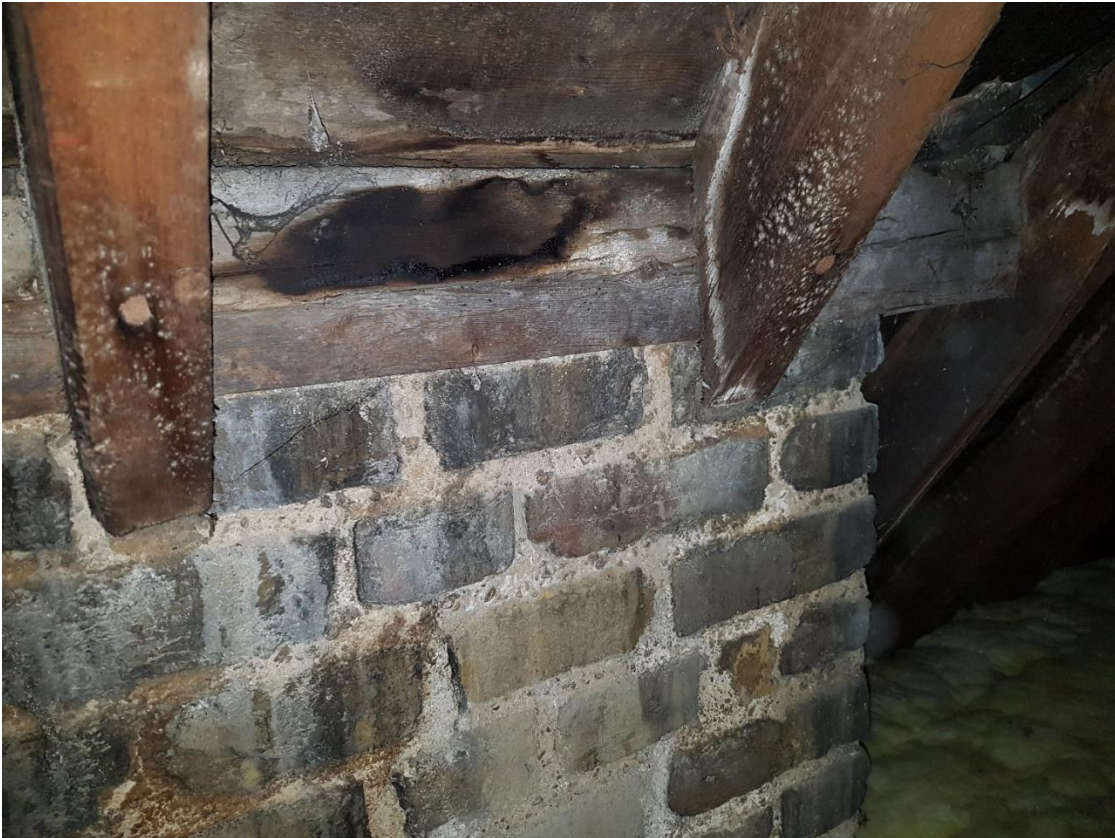
14. Damp and decay was noted to the front timber valley lining and to the timbers to the perimeter of the chimney breasts. These should be cut out and replaced.

Damp ingress around chimneybreasts in the roof space

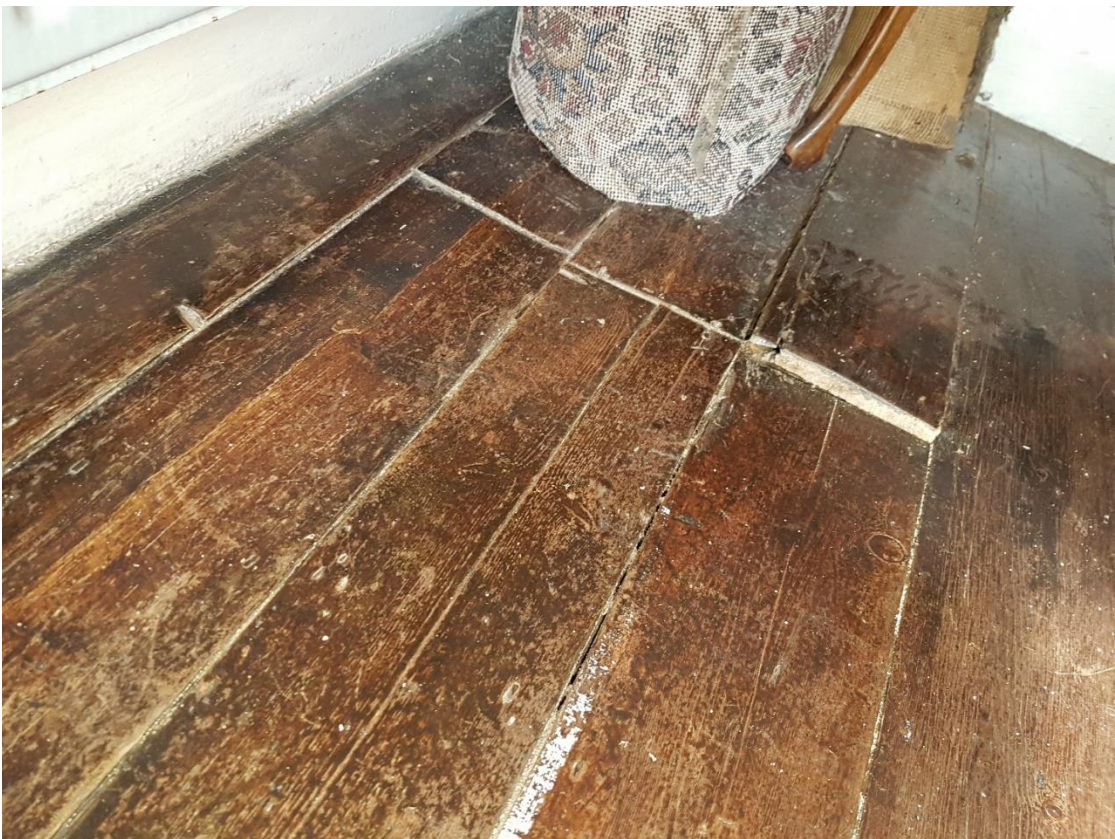
19. Timber floorboards were noted to be squeaky underfoot and evidence of historic woodworm infestation was noted to first floors in particular. You should arrange for the timbers to be inspected by a timber preservation company who may recommend some treatment to ensure that any future outbreaks of infestation are eradicated.

Evidence of historic woodworm infestation

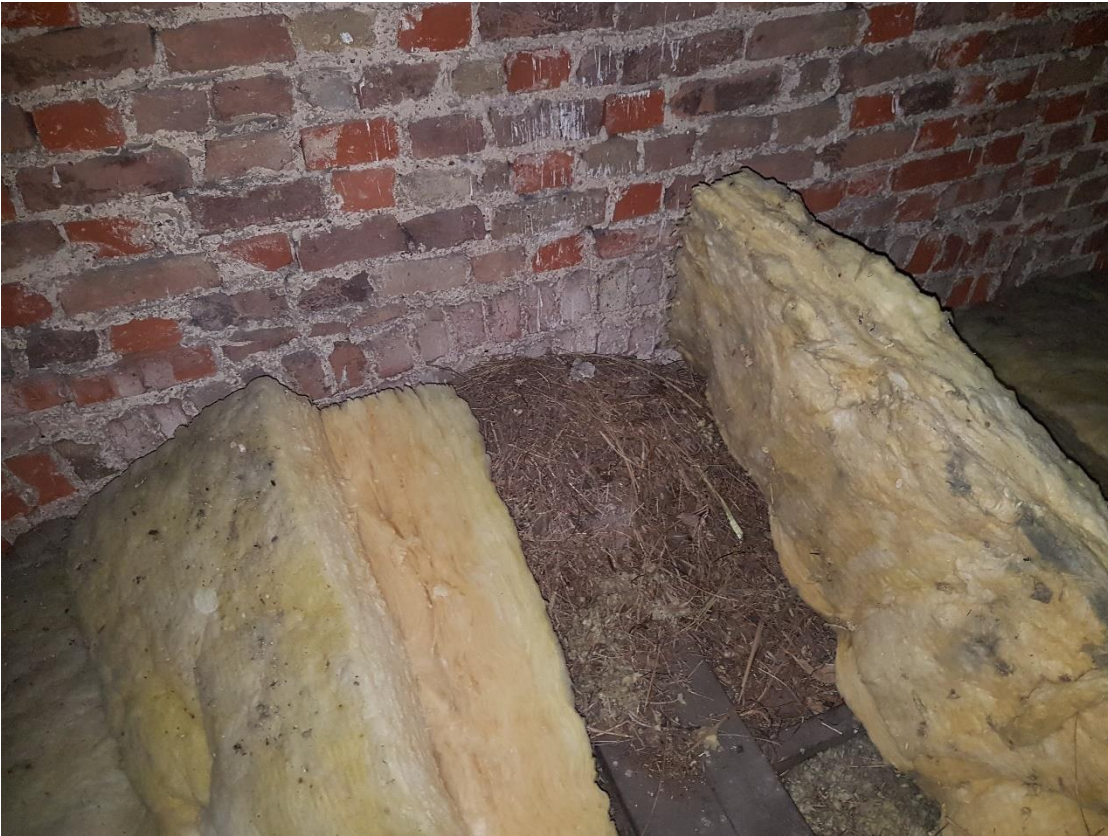
13. 1 no. large wasps' nest was noted within the roof space and a number of smaller wasps' nests were also noted. Two birds' nests were noted within the roof space. These should ideally be removed and the perimeter gaps sealed.

Birds' nests in the loft

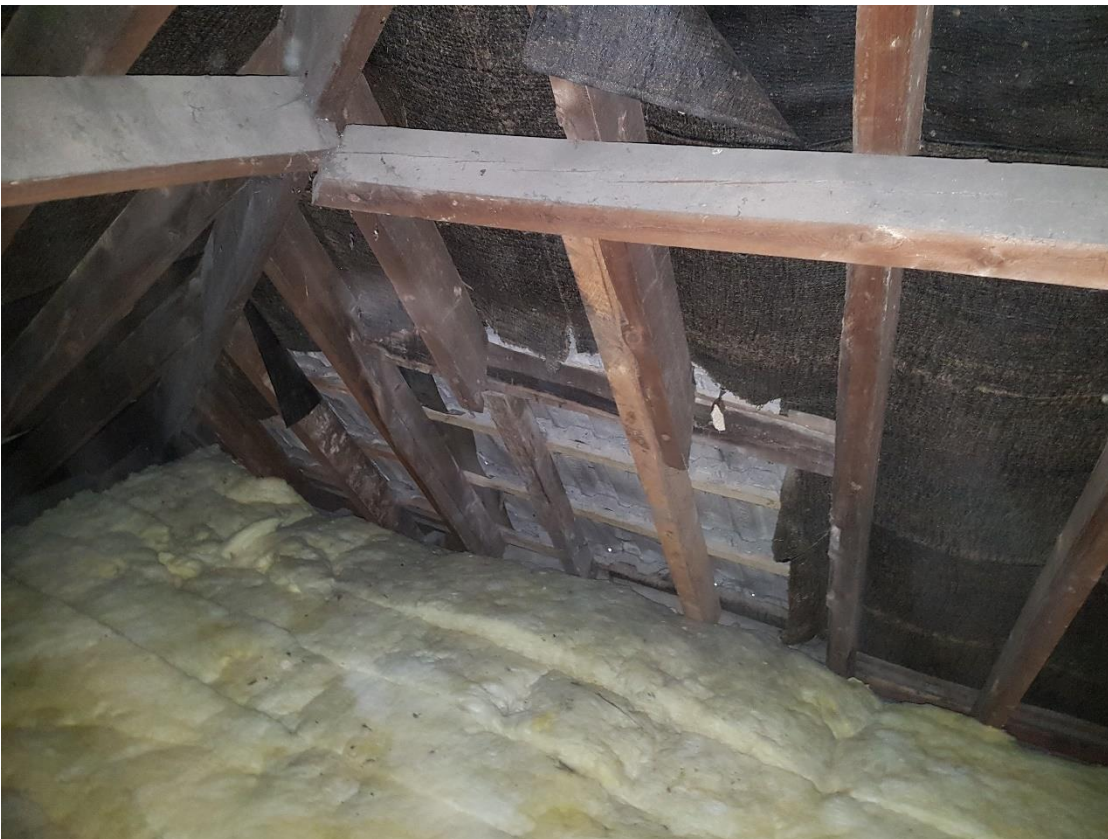
11. Within the roof space it was noted that underfelt has been torn in a number of places and should ideally be replaced.
12. Within the roof space it was noted that there are gaps to the perimeter edge which will have allowed birds and wasps into the roof space. The perimeter gaps should be sealed.

Missing underfelt in the loft space

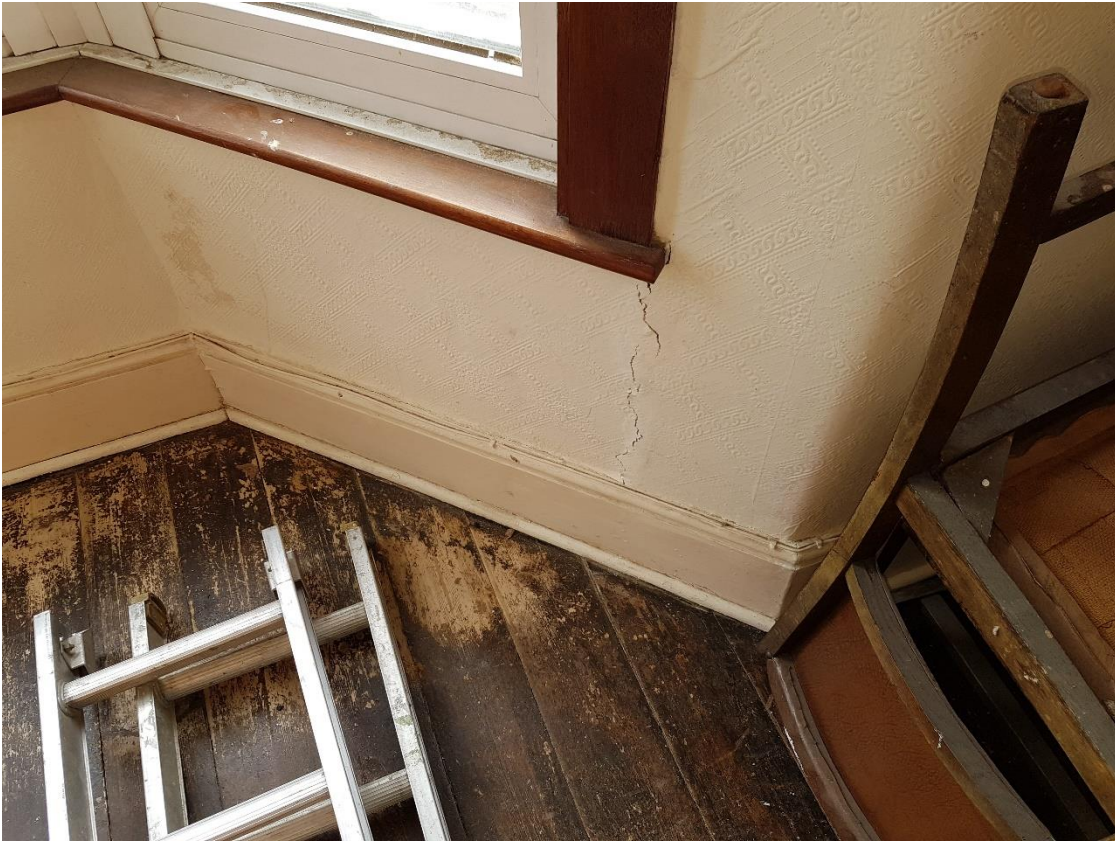
6. Some additional airbricks would be beneficial to the rear elevation.
7. Some gaps were noted around the perimeter of the bay window. These should be sealed to avoid damp ingress. Internally during the refurbishment, you should arrange for the plaster to be hacked off in this area and potentially for some additional minor structural repairs such as stitching and bonding to be carried out in this area.

Cracking to the bay window

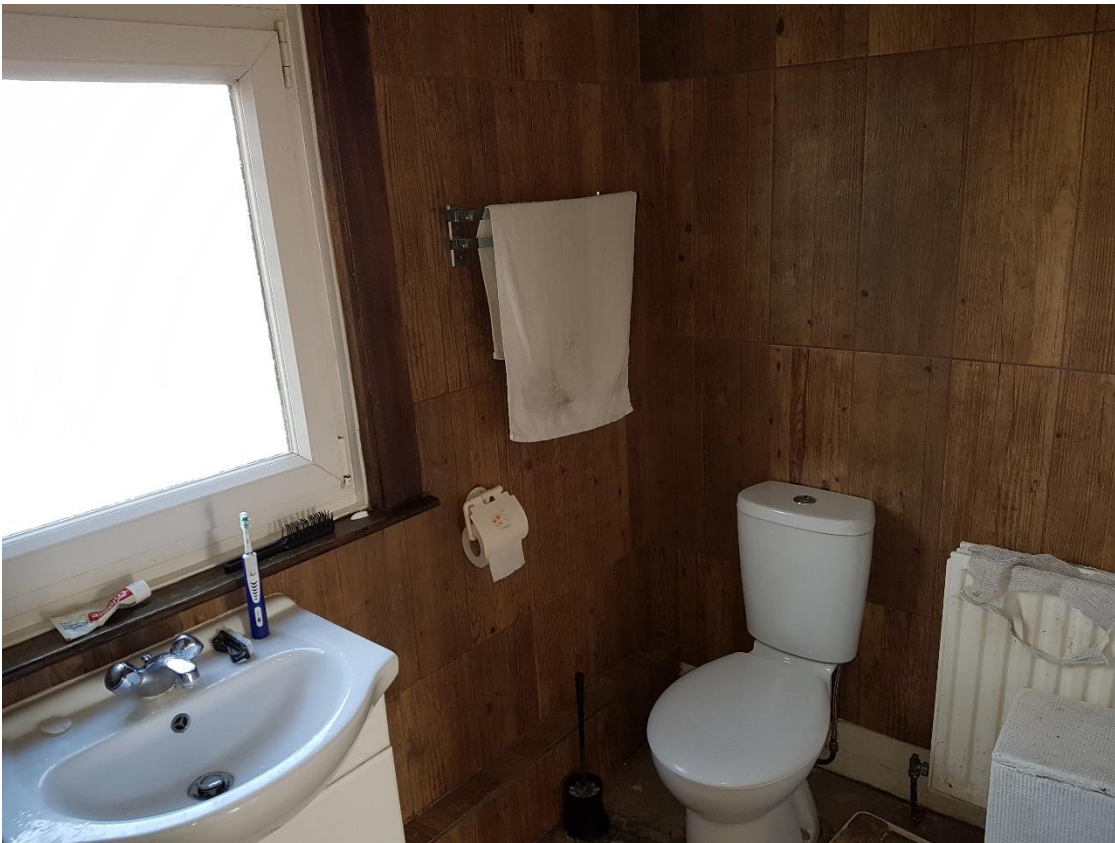
18. Some of the walls, particularly within the kitchen and bathroom have had a lining finish applied. Once this has been removed defects to the underlying plaster may be discovered. It is likely that repairs will be required.

The inside face of external walls within the kitchen and bathroom in particular have been lined. You should be aware that the presence of lining such as this means that it is difficult to assess the condition of the wall structure behind to ascertain for example whether rising or penetrating damp is occurring. When the lining is removed some repairs may become evident.

Wall linings to the Bathroom

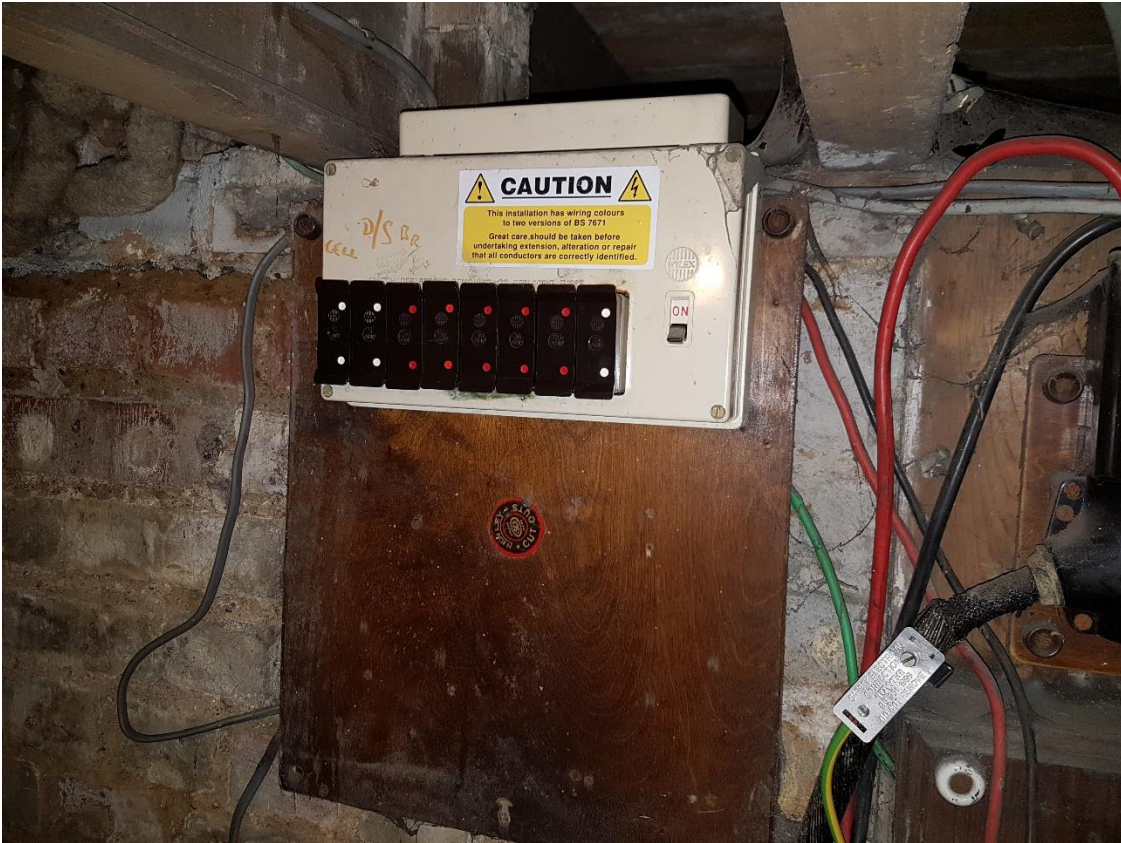
The Electrical fuse board is dated

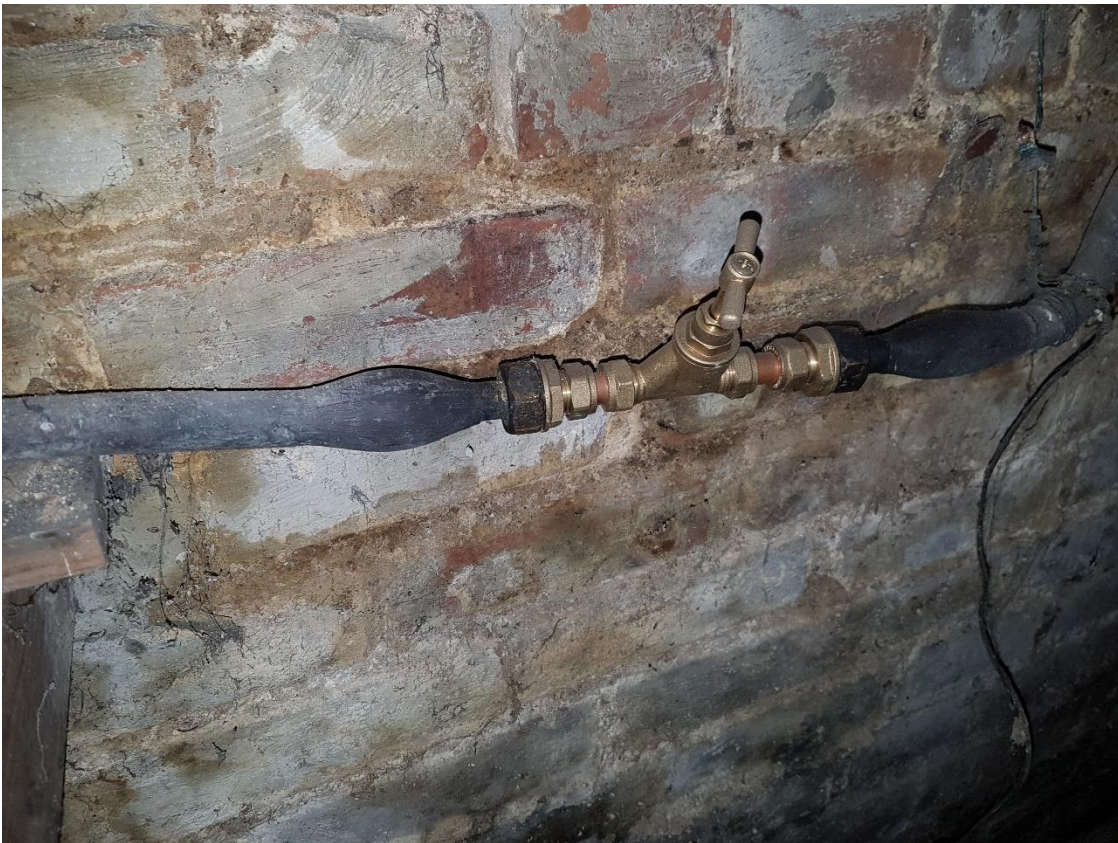
Lead pipework was noted in the basement

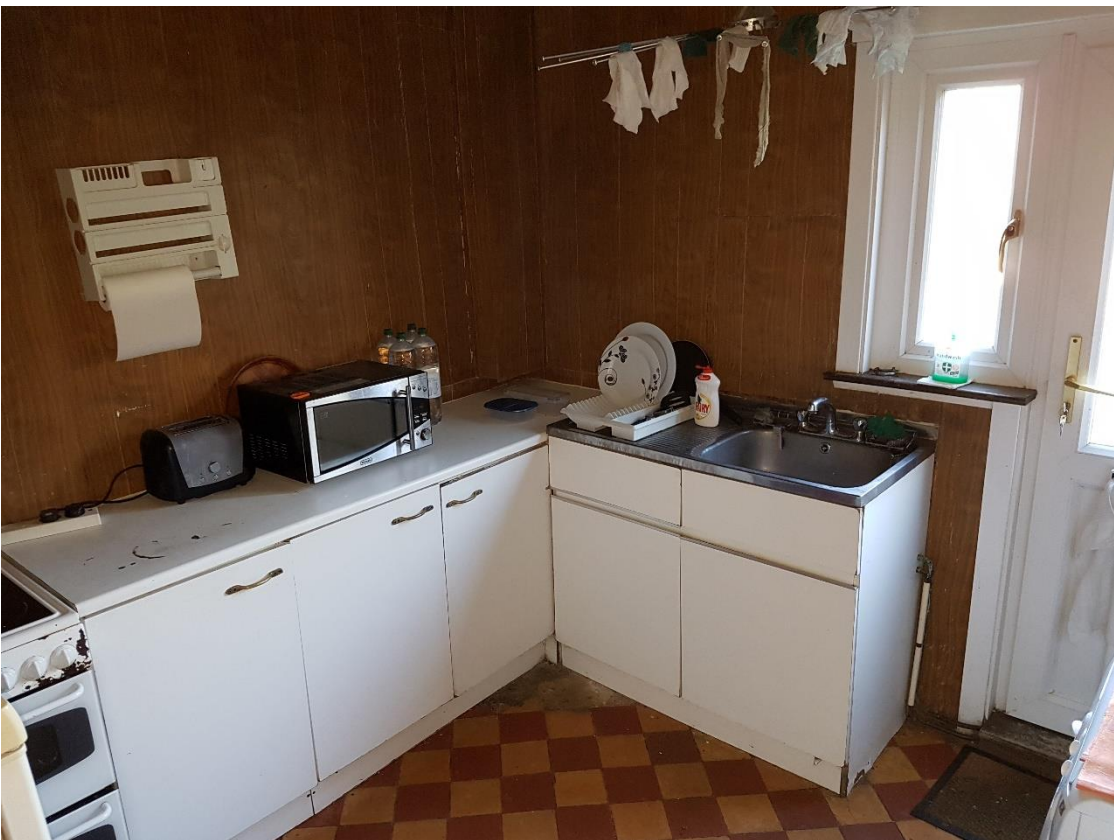
The Kitchen is dated

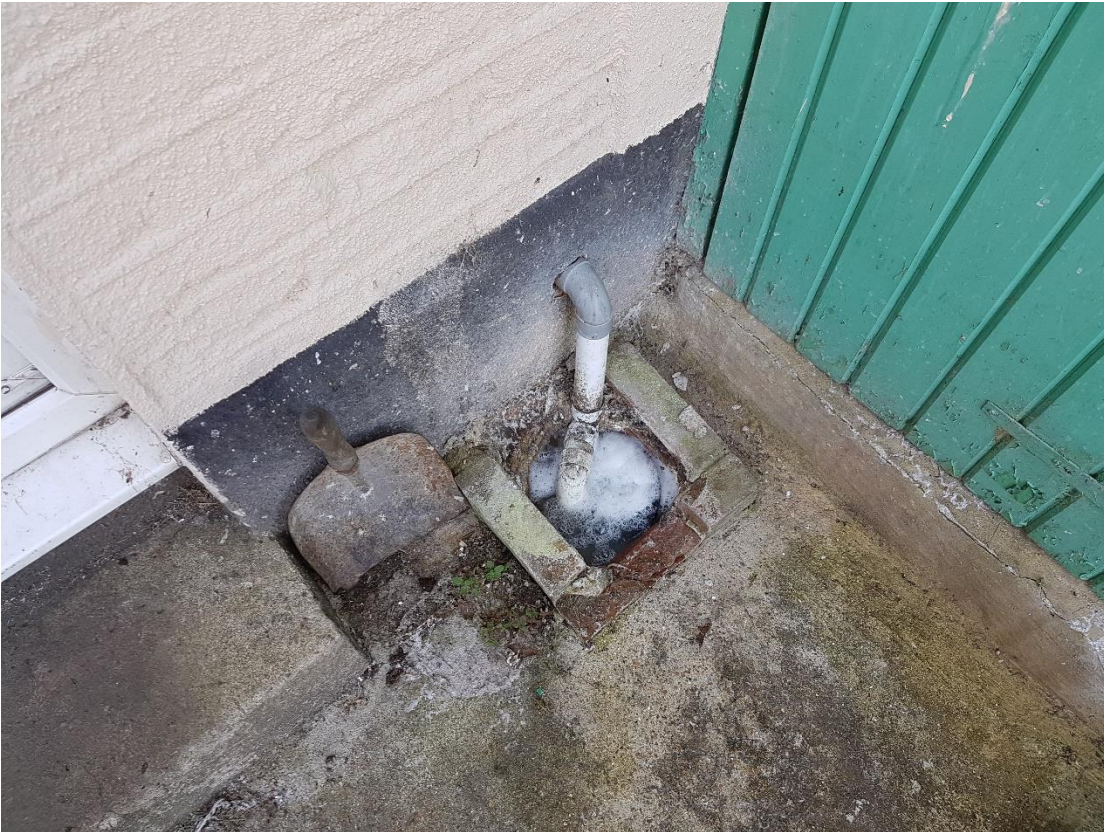
The rear external gully backs up

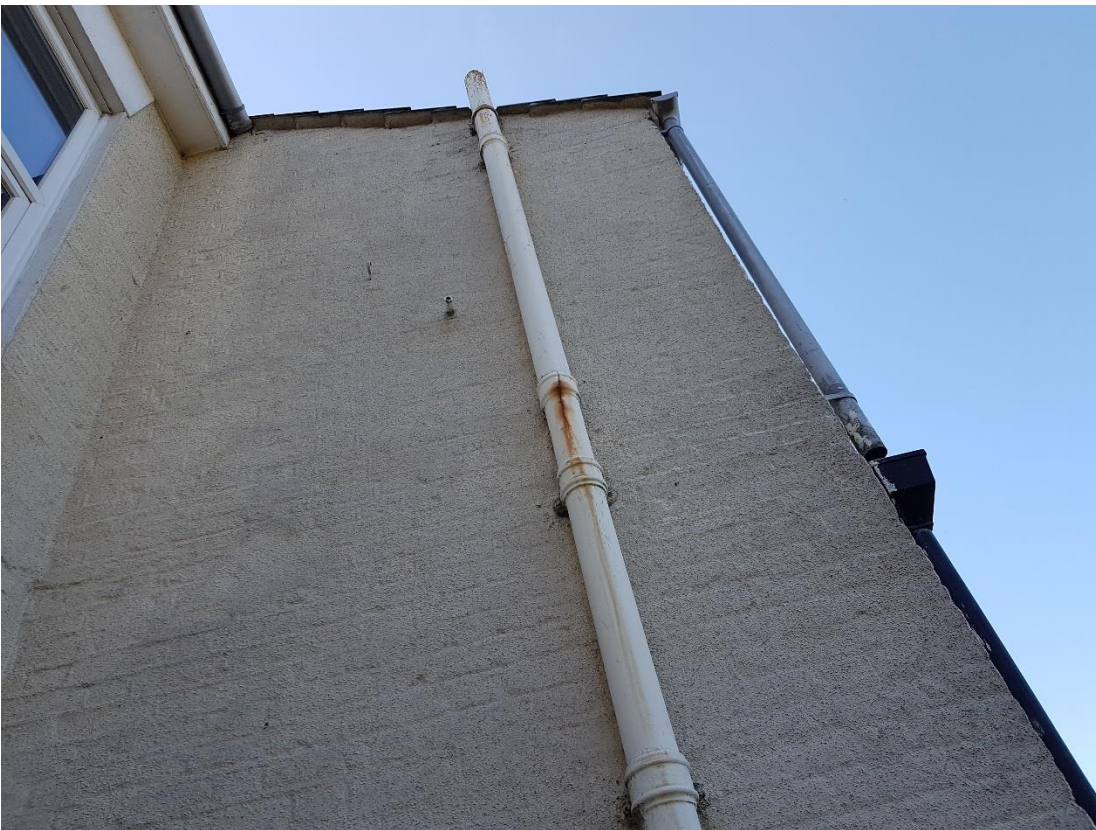
8. The gutters and downpipes to the property are of some age. The gutters are suspected to leak and corrosion was noted to cast iron rainwater fittings, some of which have split. You should budget for complete replacement throughout.

The cast iron rainwater fittings were seen to be corroded through lack of maintenance. Damaged sections should therefore be replaced. Although it is still possible to buy metal rainwater fittings, replacement with plastic fittings is considerably cheaper.

Damage to a Cast iron pipe

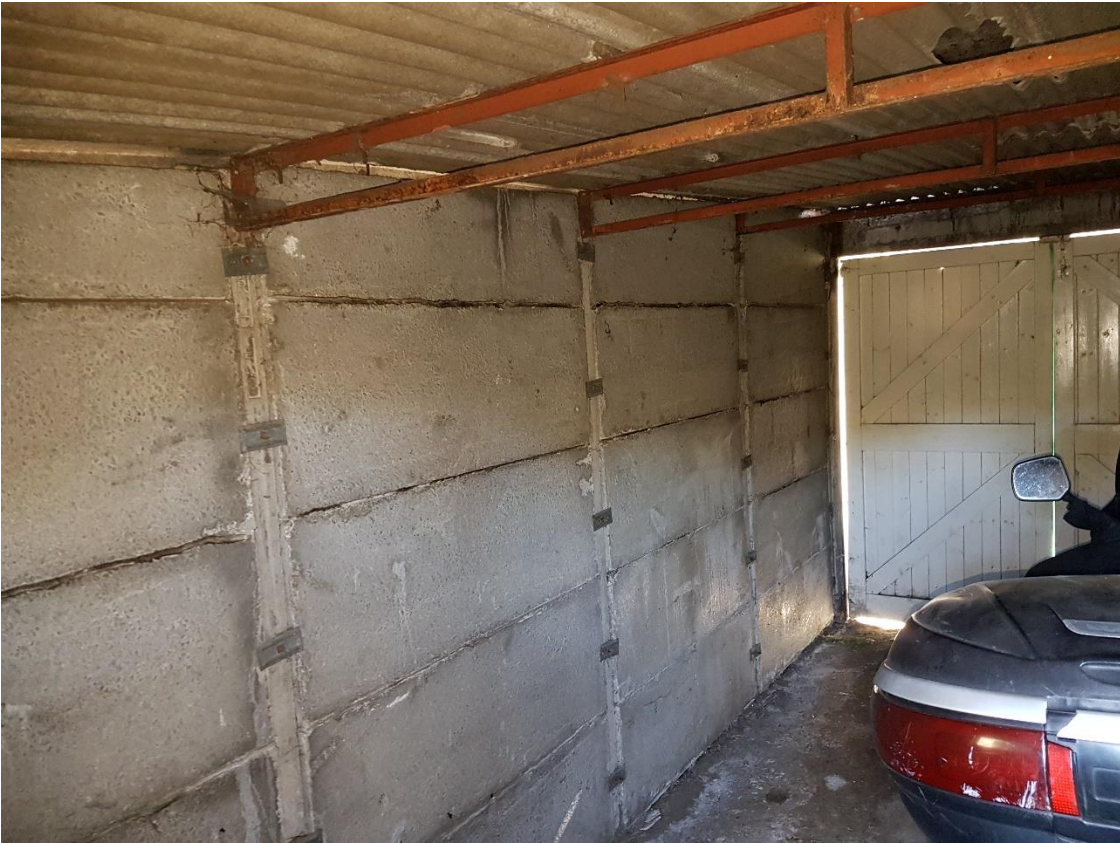
10. You should be aware that the garage is of a material which is likely to contain asbestos. Although intact and fit for purpose at the present time, any repairs to the garage should be carried out by a specialist which will make these more expensive.

The garage wall and roof panels are likely to contain asbestos

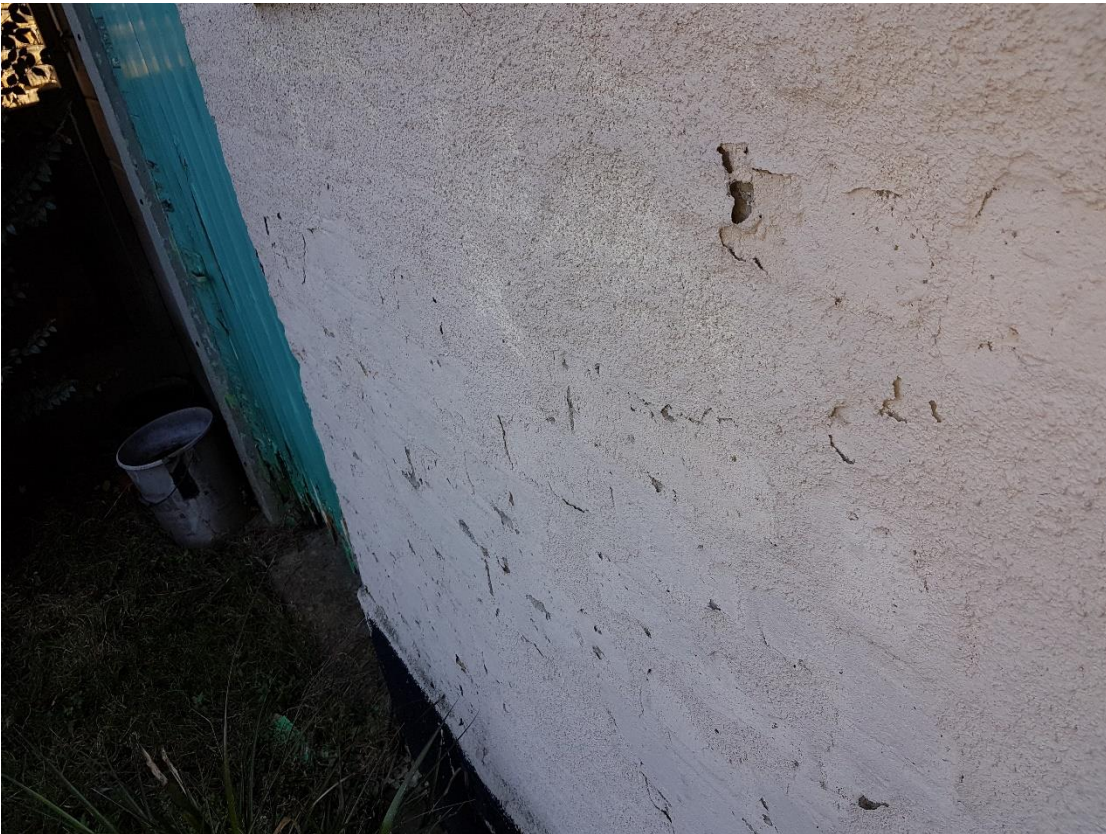
The brickwork has been painted. Brickwork is not intended to be painted as the paint can prevent the natural drying out process after the bricks have been exposed to rainwater. Moisture can become trapped behind the paint and frost action may then cause additional damage to the bricks and the joints as well as causing deterioration to the paint finish.

The external paintwork requires attention

Once painted it can be difficult and costly to remove the paint finish and this is usually considered uneconomical. Loose paint should therefore be brushed off, the bricks made good as necessary and redecorated with a good quality micro-porous paint which will allow the brickwork to breathe.

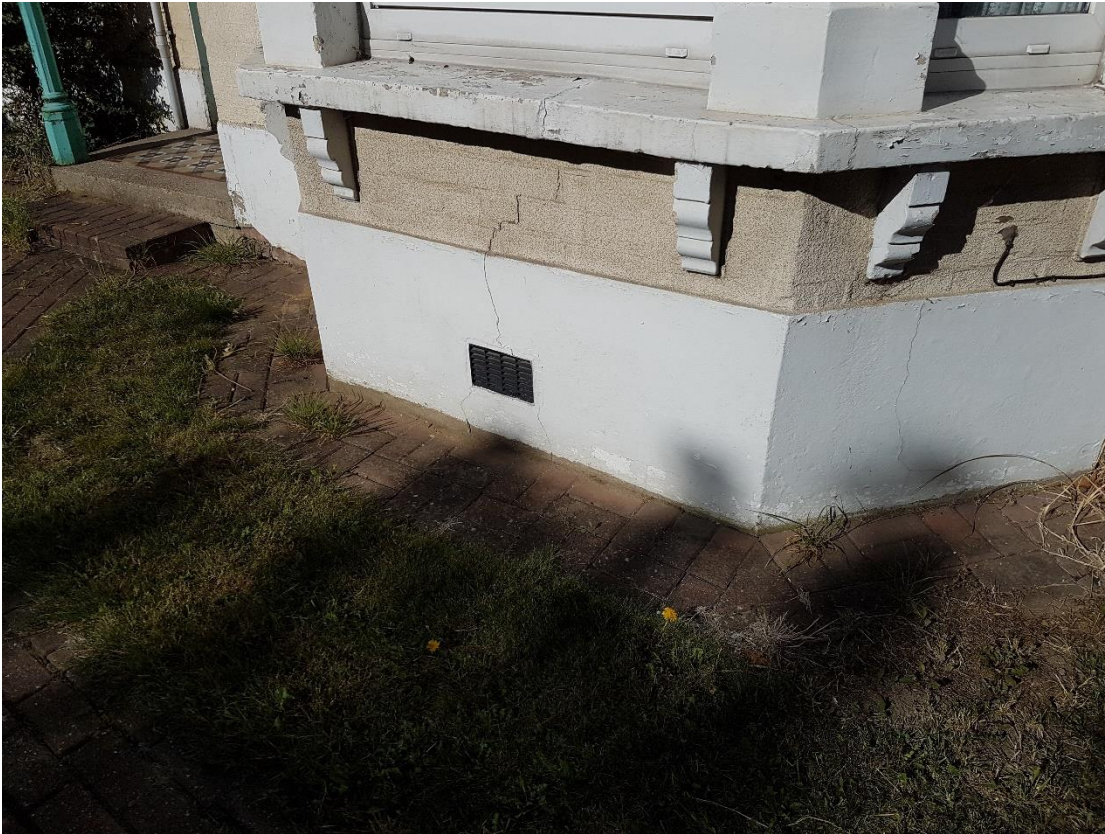
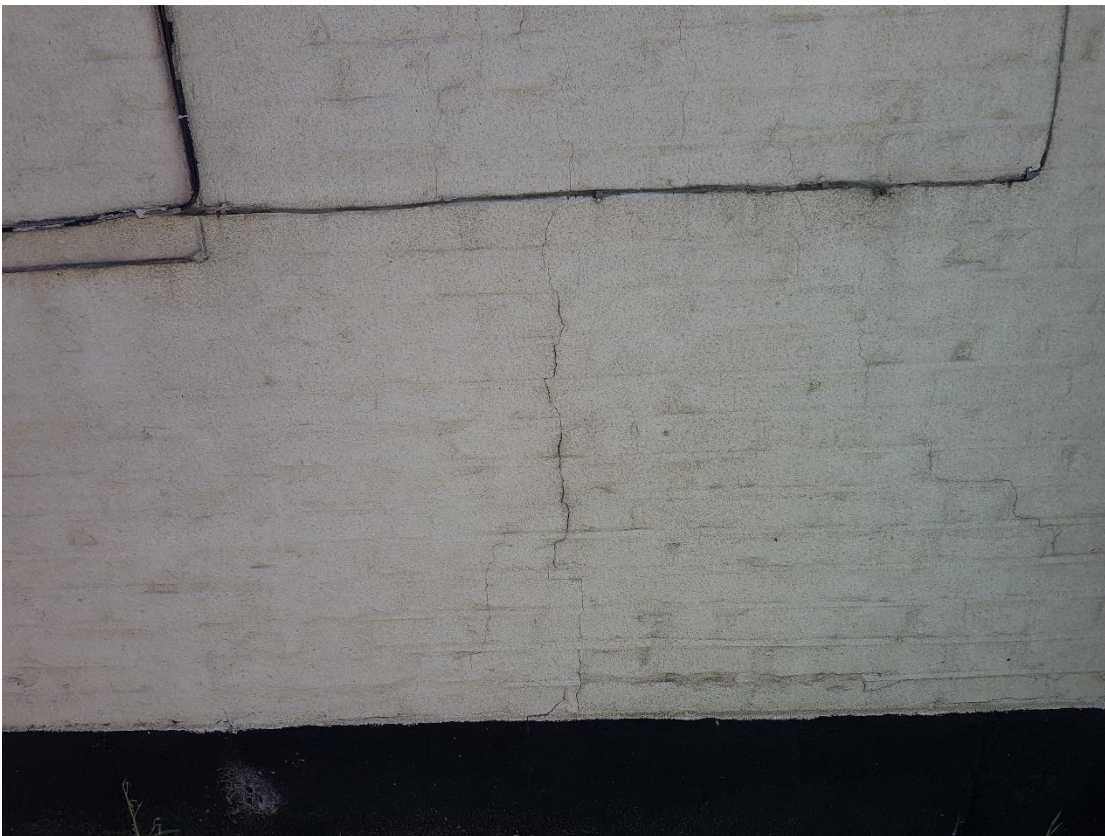
2. Externally various cracks were noted indicating as above, that some movement of the property has occurred in the past. Externally the brickwork elevations have received a paint finish. You should ensure that any cracks externally are fully sealed to avoid damp ingress occurring. Internally given that the property requires full refurbishment throughout it may be necessary to consider hacking off the plaster in areas immediately adjacent to corresponding cracking externally and for some element of

The external walls to the property are of solid masonry and they were seen to be in a condition typical of a property of this type and age other than some minor cracking noted which is consistent with the previous subsidence issue.

External cracking to walls

minor structural repairs, such as stitching and bonding to be carried out to these if this has not already been carried out.
