BUILDING CONDITION SURVEY AND SUMMARY REPORT

**Example Property
London
E17 5FF**

Ref. no. 2040.01

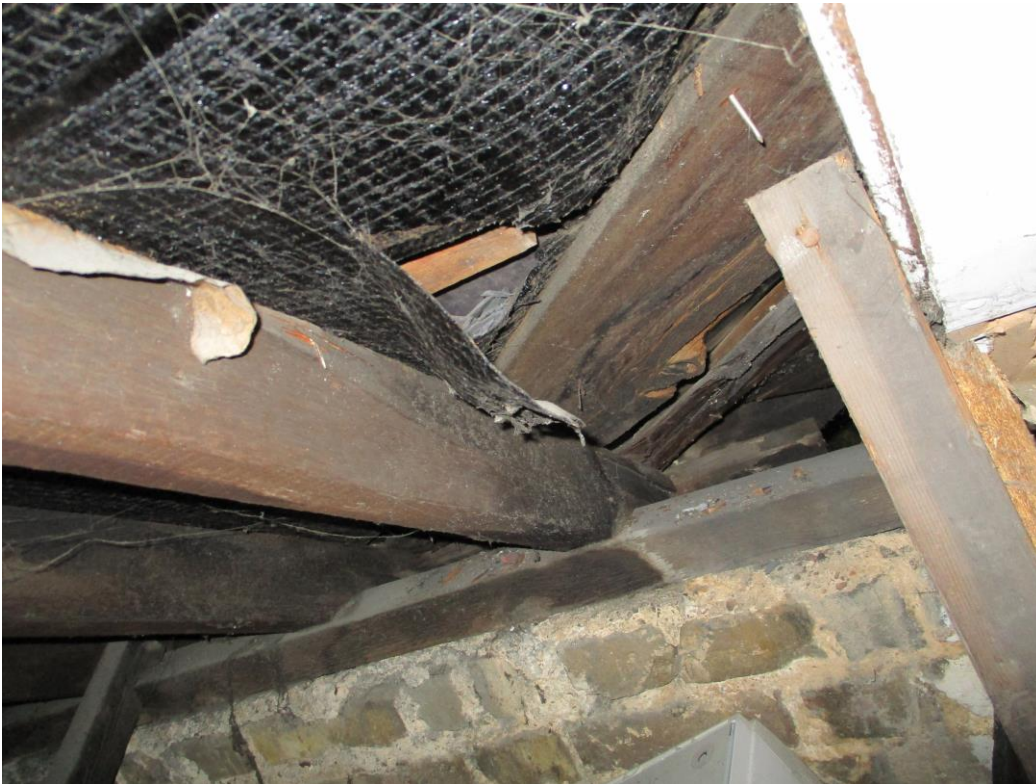
Damp ingress within the roof space

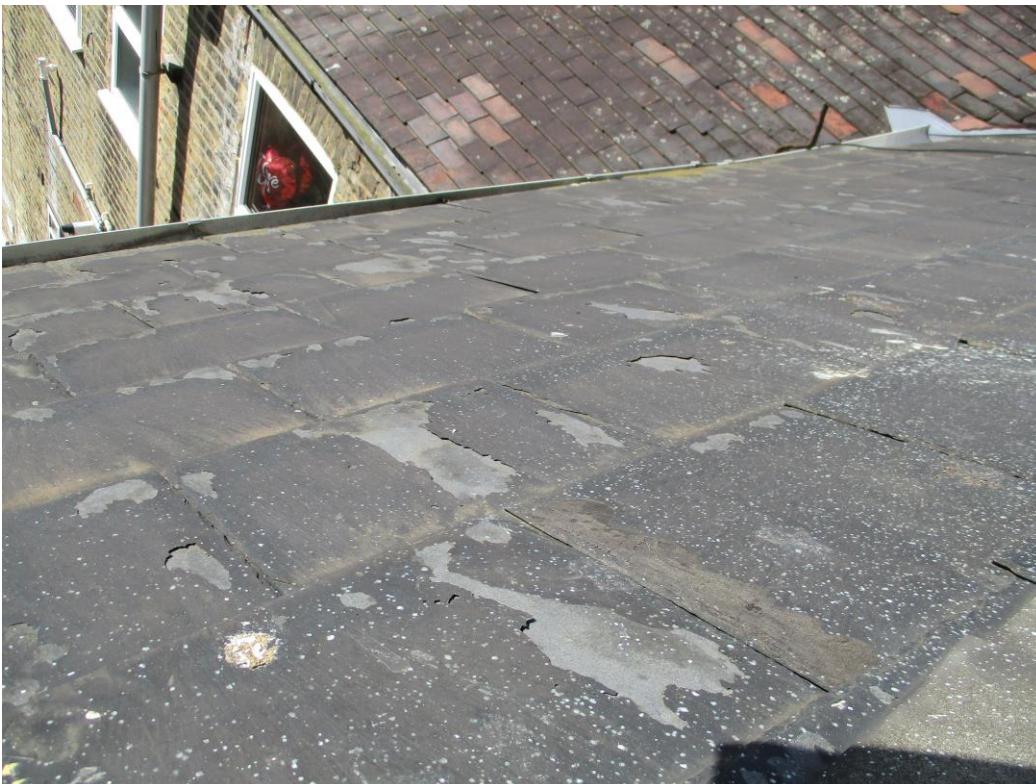
Old slates have reached the end of their useful life

- 1 The main roof over the property requires a substantial overhaul. Internally within the roof spaces evidence of damp ingress was noted. The slate covering appears to be original and a number of missing and slipped slates were noted. The perimeter flashings at junctions are predominantly of mortar which is an inferior method and is now allowing water ingress. We would recommend that the mortar flashings are upgraded to leadwork and the slate covering is removed and replaced. Some elements of timber decay and replacement of timbers will be required.

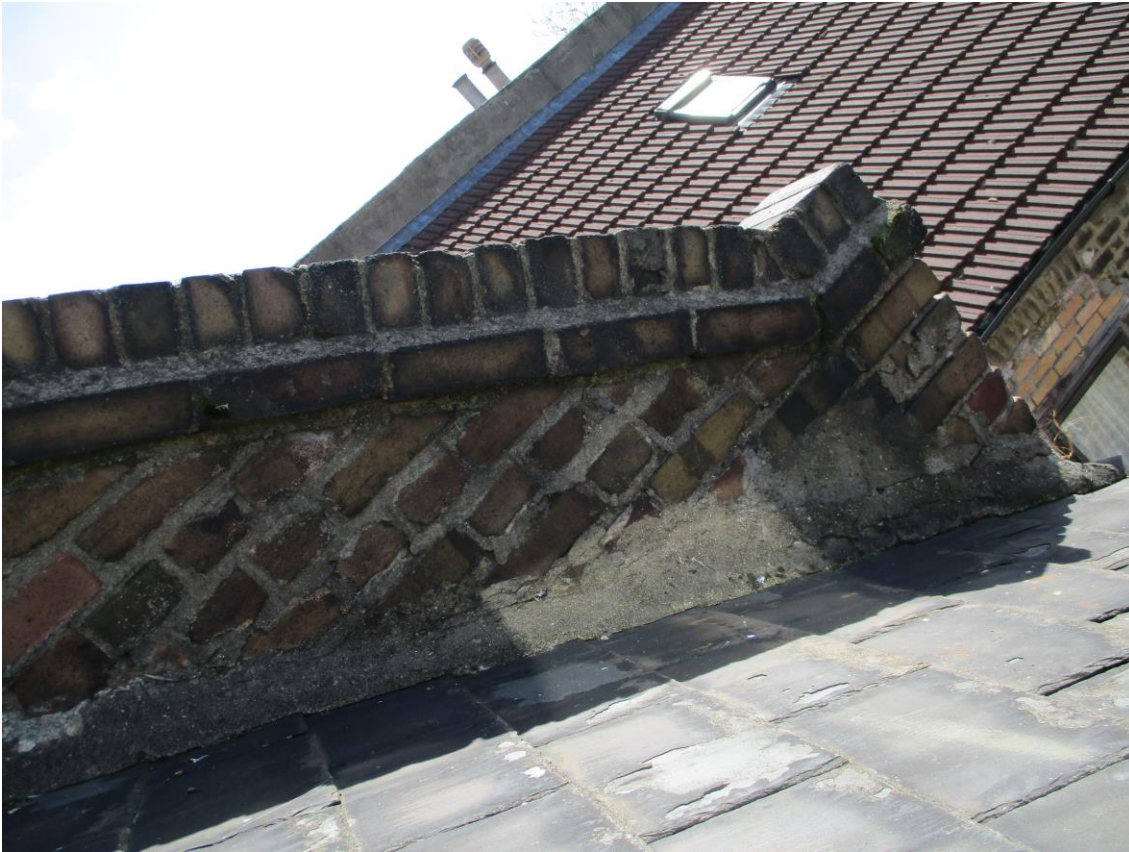
Mortar flashings are allowing water ingress

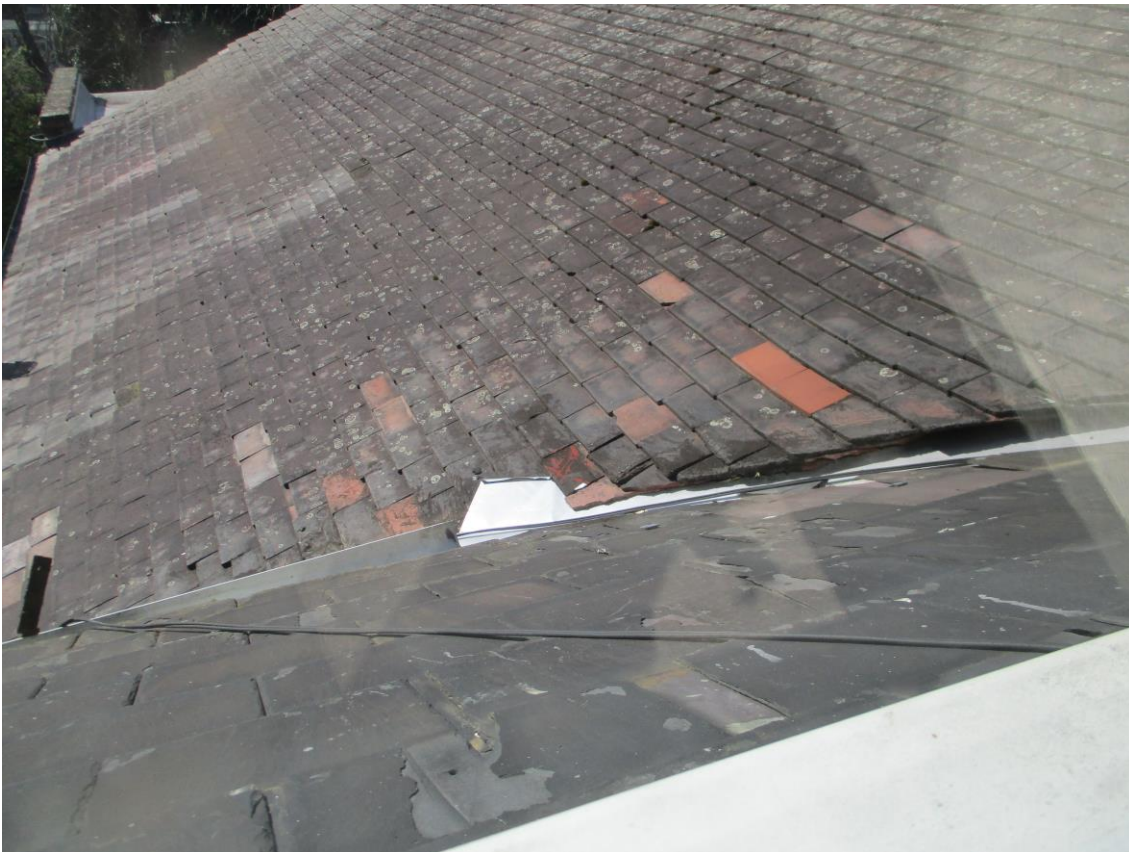
The valley junction to the rear is allowing water ingress

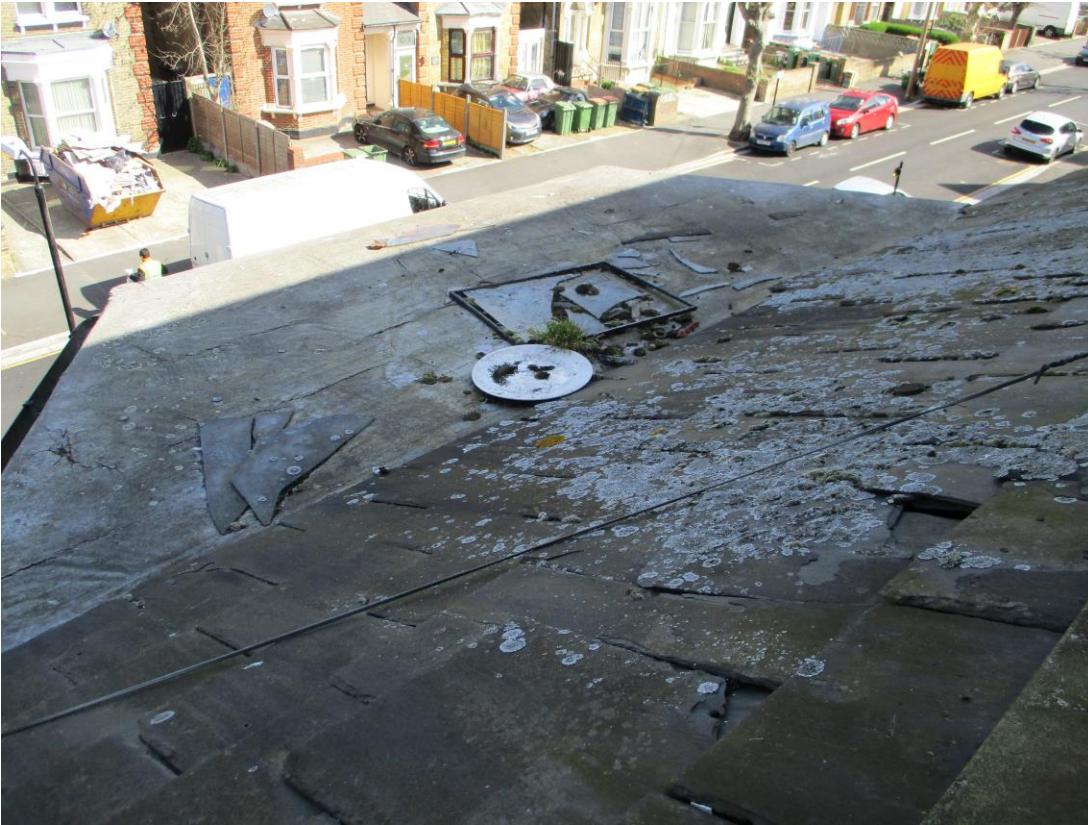
The front slate roof and bay roof covering are in poor condition

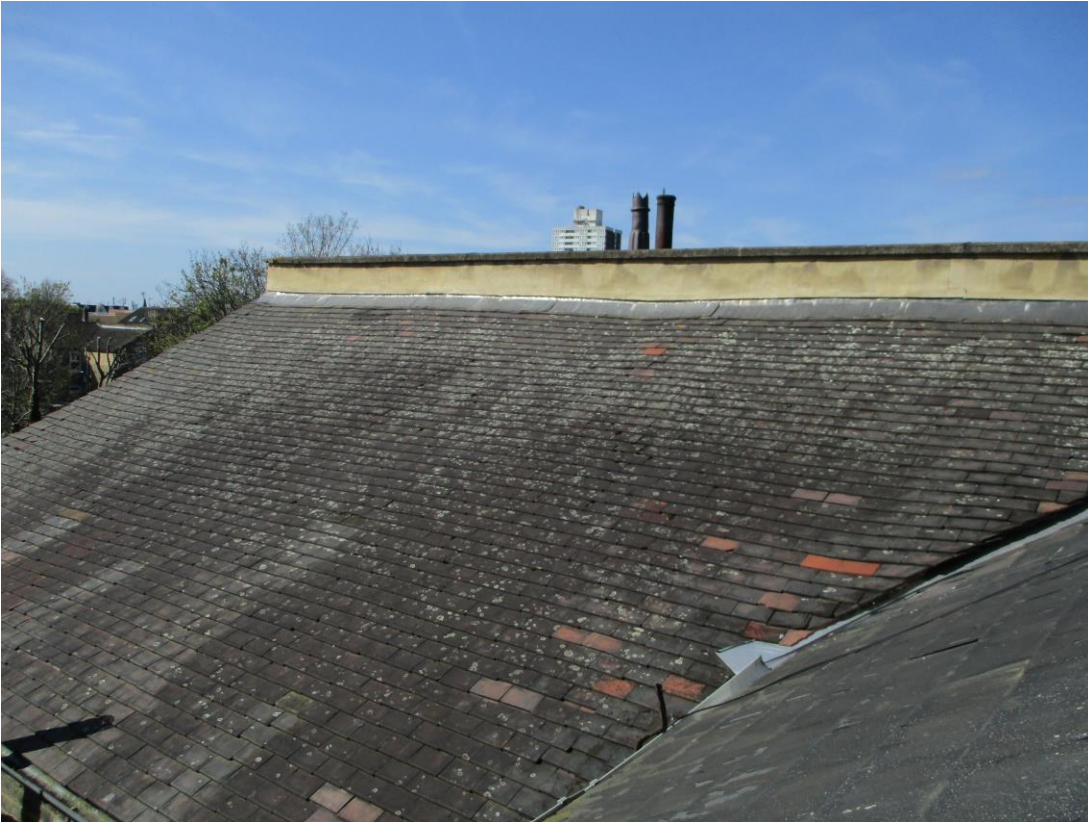
The rear tiled roof is in better condition although some slipped tiles were noted and evidence of damp ingress internally.

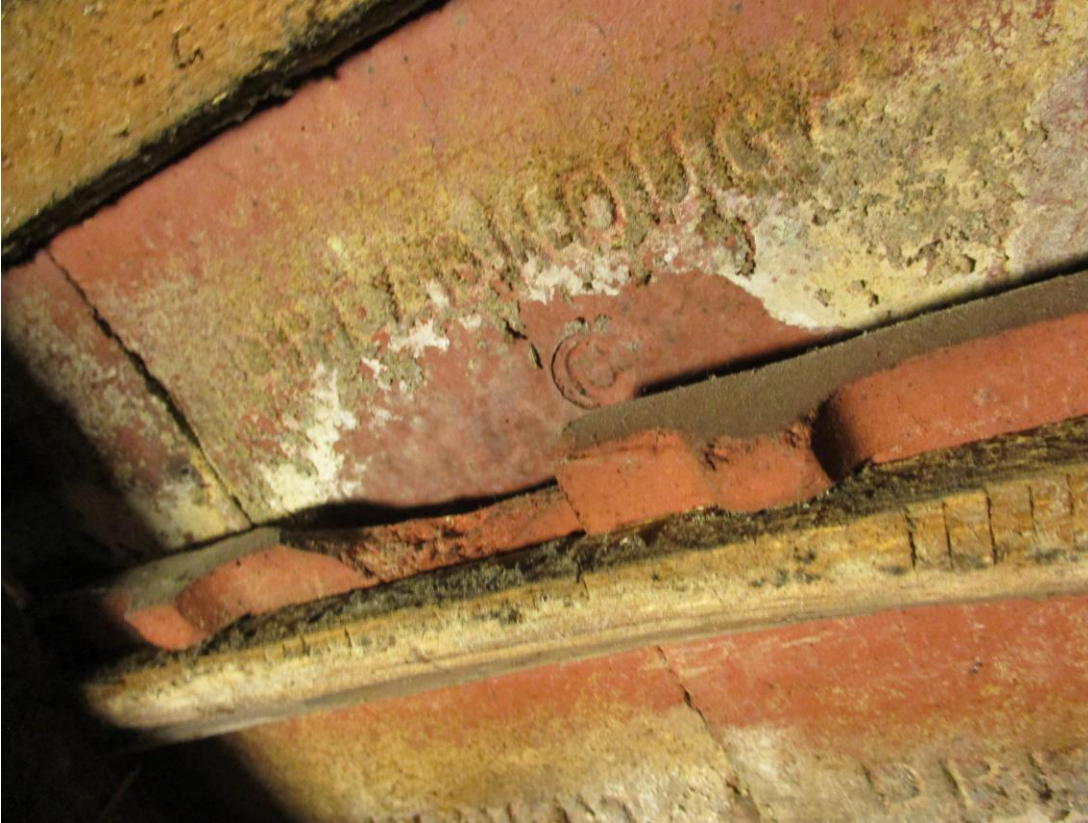
Broken “Nibs” to tile internally mean it is inevitable this tile will “slip”

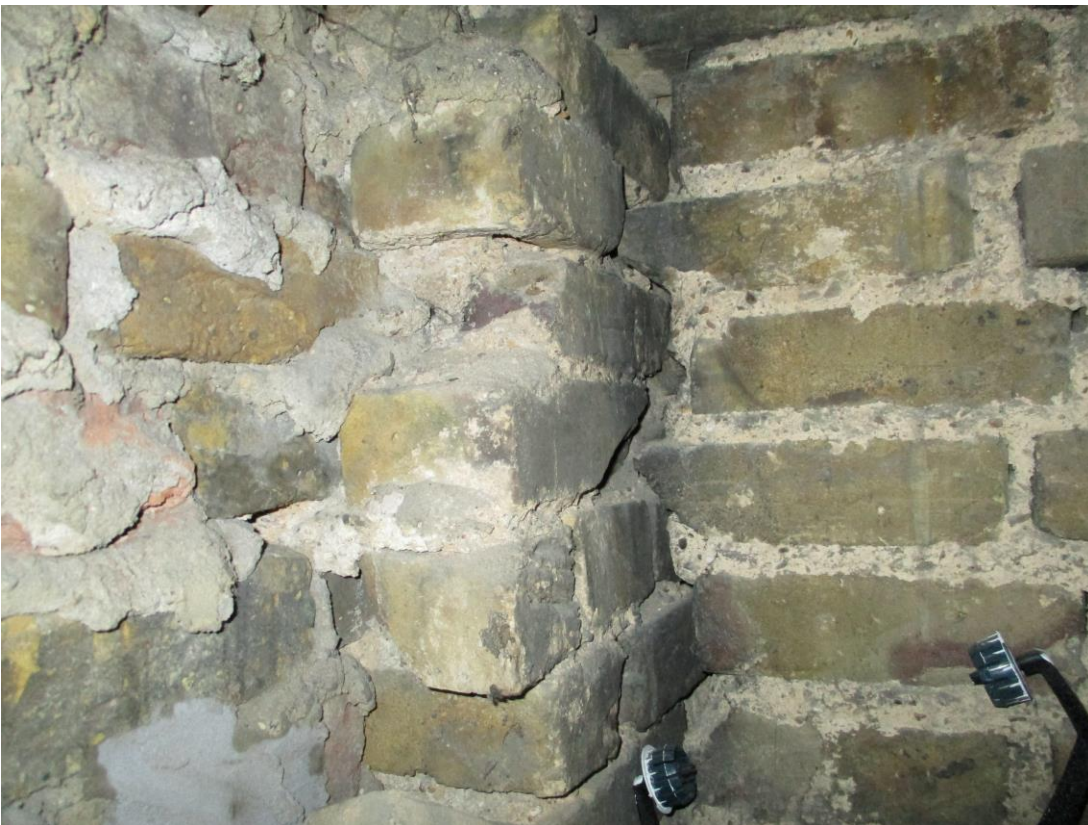
Open junction within the rear roof space

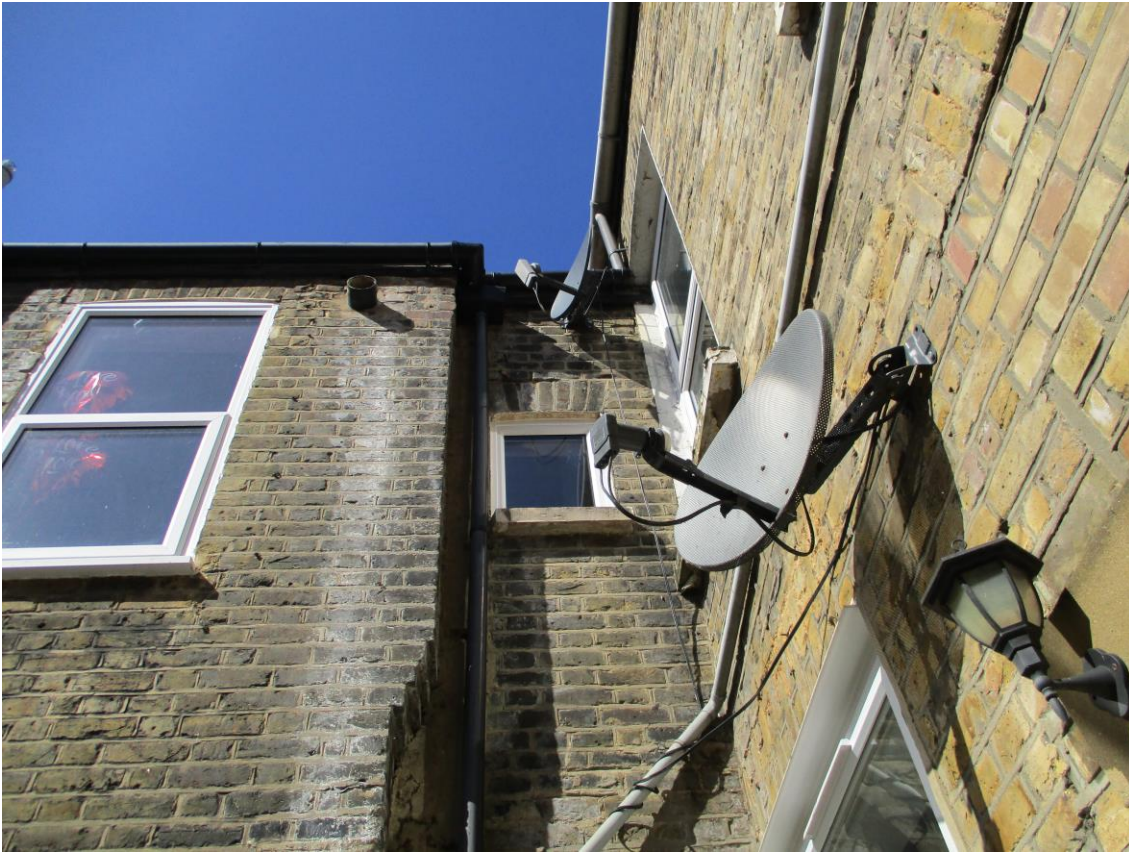
Damage above Lintel requires repair

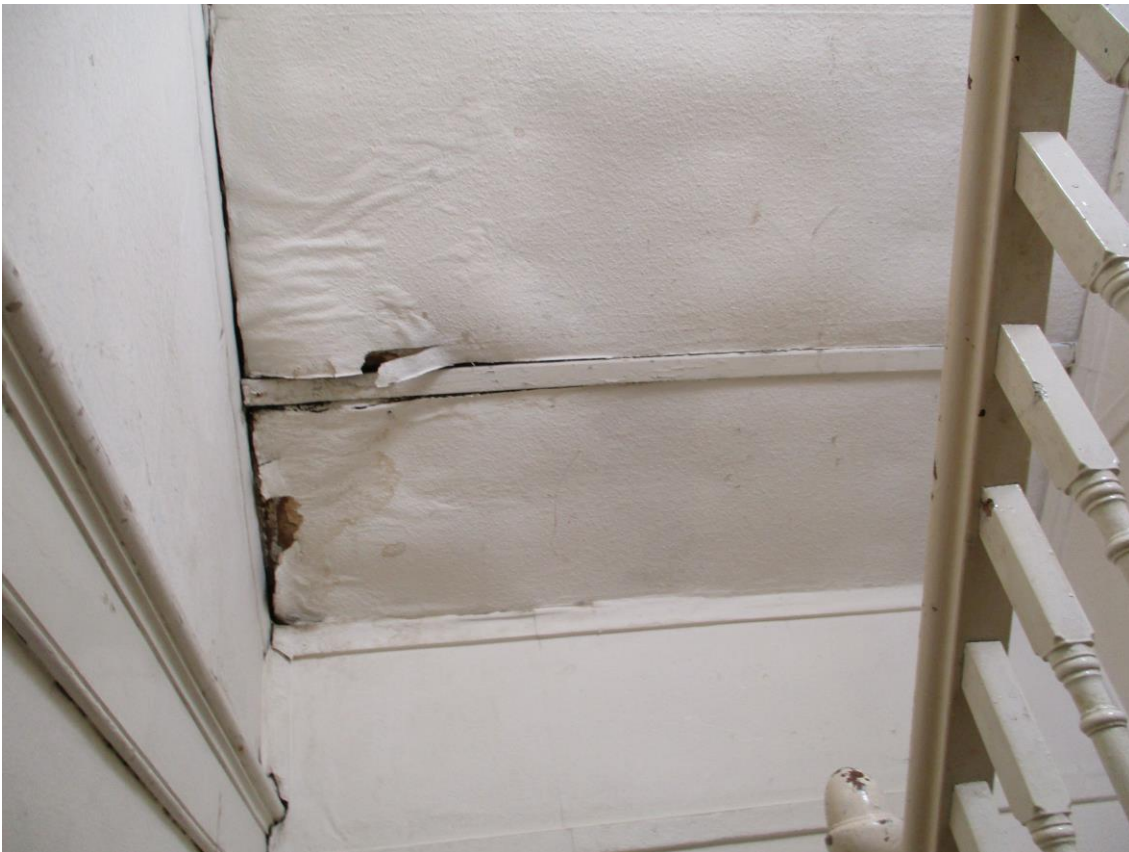
Damp ingress within the stairwell

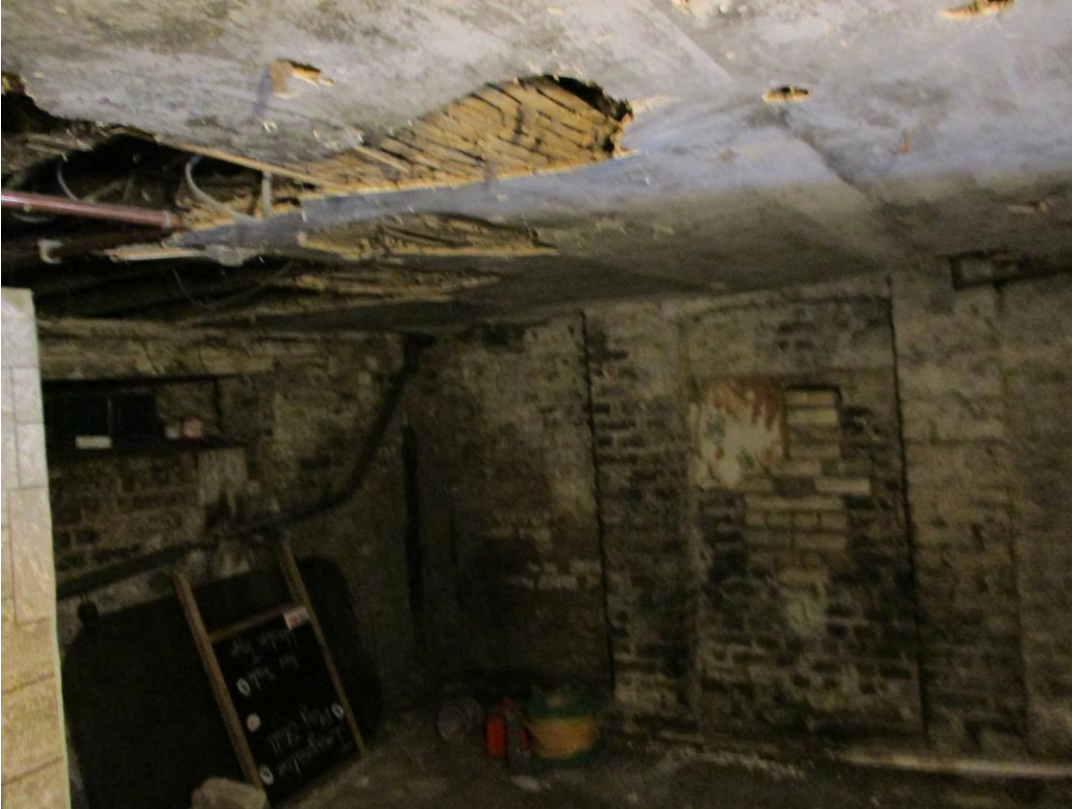
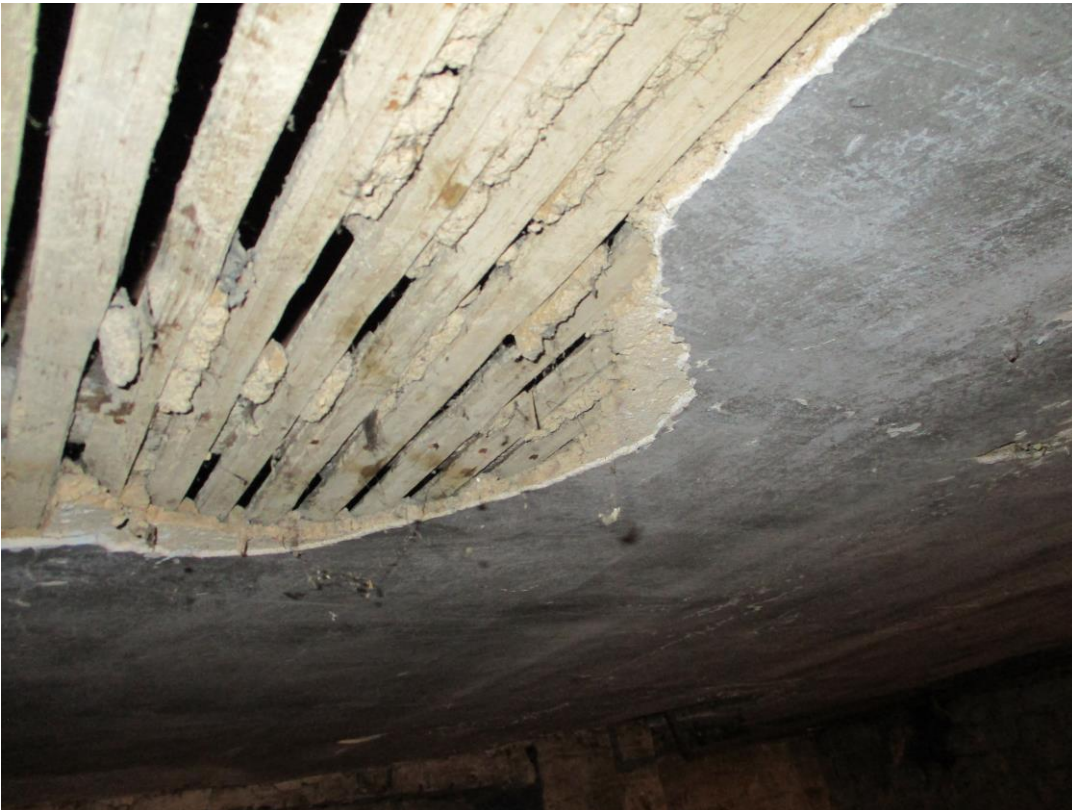
Finishes within the basement require upgrading
